# Measurements of level of rebar corrosion and surface cracking for structural health monitoring

S. Shakib & A. Z. Morshed

*Khulna University of Engineering and Technology, Khulna-9203, Bangladesh*

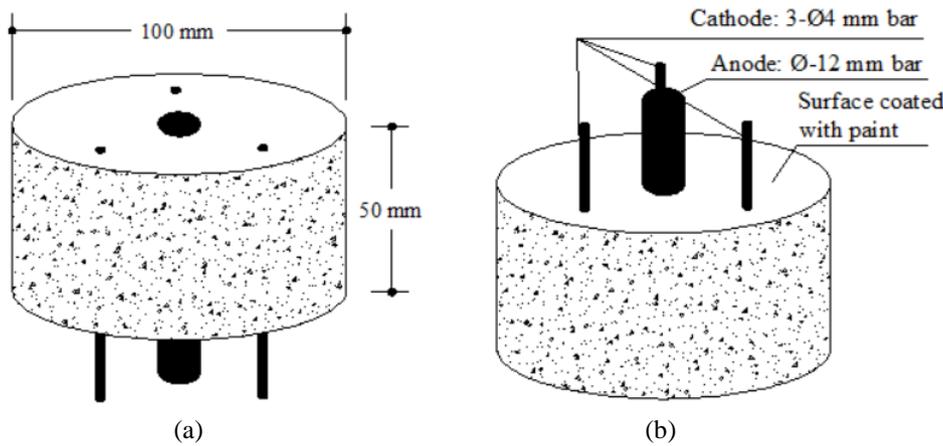
Figure 1. Details of specimen (a) top view (b) bottom view

mm<sup>2</sup>) may corrode in accelerated corrosion tests. The anode and cathode bars were embedded in a cylindrical concrete specimen of 100 mm in diameter and 50 mm thickness. The test specimen is shown in Figure 1. The 12 mm diameter bar (anode) was placed in the center of the specimen and three 4 mm diameter wires (cathode) were placed equidistant from each other as well as from central anode bar. It was assumed that, all the current is consumed to oxidize the steel in accelerated corrosion test. So that a certain amount of chloride ions is needed in the concrete. Before conducting the accelerated corrosion test the specimens were soaked at 3.5% NaCl solution for at least 1 day.

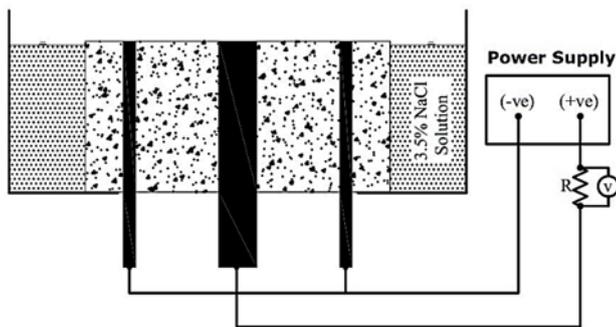
Figure 2. Details of test setup

In the electrochemical corrosion process a microcell is formed after the steel has de-passivated and a potential difference is created between the corroding bar and the surrounding corrosion products which further accelerates the corrosion of steel. To simulate this phenomenon in a short time, an external DC power supply was used to apply a direct current between the anode (steel reinforcement) and cathode. The test setup is shown in Figure 2. A power supply of 30 V, 1 A was used. A constant voltage of 30 V was applied across the anode and cathode and the voltage drop across the fixed resistor was measured. From which the current supply was calculated by Ohm's law ( $I = V/R$ ). The top surface of the specimens was polished and smoothed with grade 400 sand paper and then cleaned with air blower and duster cloth. The bottom side of the specimen was sealed with epoxy paint before ponding it in 3.5% NaCl solution in such a manner that the chloride ions could penetrate only through the side surface. The thickness of corrosion product layer and crack width were observed by a magnifying USB digital Microscope, shown in Figure 3. The top surface of the specimens was dried and cleaned again before taking each photograph.

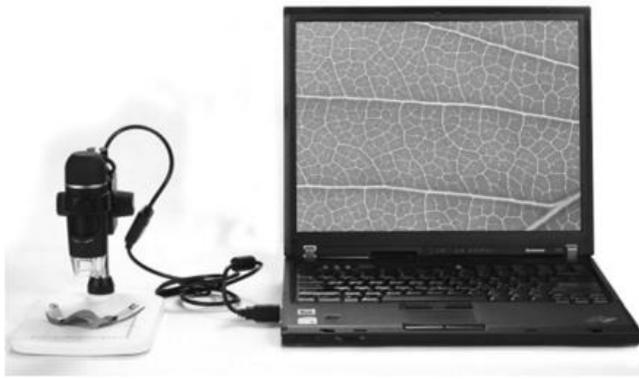
Figure 3. USB Digital Microscope

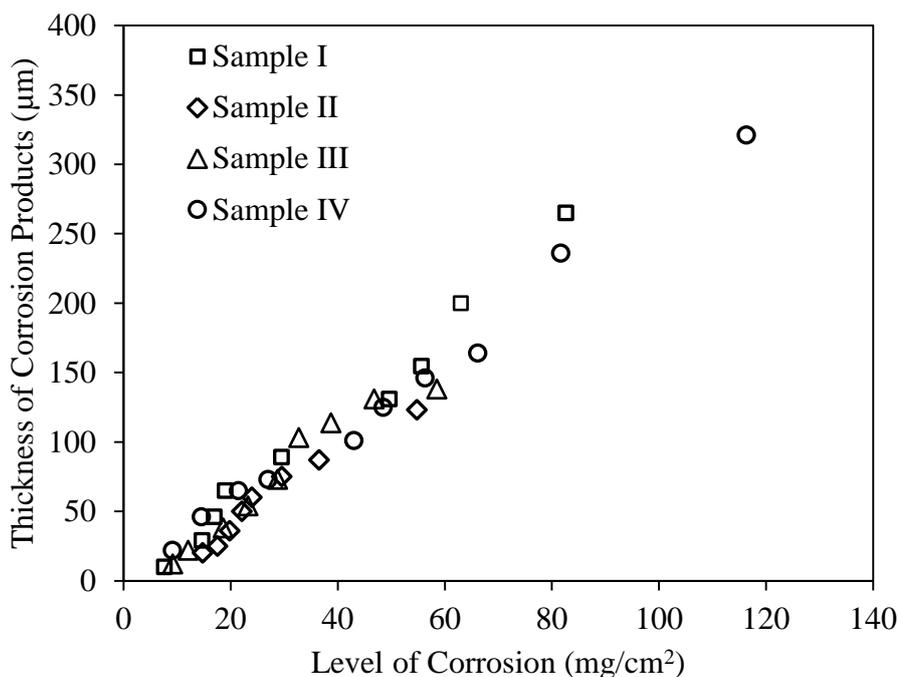
Color photographs, taken by the magnifying USB digital Microscope, could clearly illustrate the layer of corrosion products and the cracks formed due to expansive nature of corrosion products. The variation of thickness of corrosion products with respect to mass loss, as shown in Figure 4, demonstrates that up to about 8 mg/cm<sup>2</sup> of mass loss, layer of corrosion products was not significantly identifiable. It seems that during that time the corrosion products mostly diffused into the micro pores of the surrounding concrete. After this level of corrosion, layer of corrosion products became visible. At a level of corrosion of 20-22 mg/cm<sup>2</sup>, first crack was visible at about corrosion product thickness of 50-73 μm. Figure 4 also shows that the corrosion product thickness follows an approximately linear relationship with the level of corrosion. Nossoni and Harichandran (2014) also found a linear relation between them up to the first visible crack. In the process of corrosion, the parent material just converted to its oxides and accumulated around it. Since no products could be losses because of having surrounding concrete, it is logical to build the corrosion products linearly around the reinforcement.

Figure 4. Variation of Thickness of Corrosion Products against Level of Corrosion

Figure 6 shows the variation of crack width with respect to the level of corrosion. The surface crack width varied linearly with the level of corrosion. The products due to corrosion, accumulated linearly around the re-bars, as shown in Figure 4, resulted in a linearly increased outbound pressure applied on the cover concrete. For this reason, the surface crack increased linearly due to this outbound pressure. The outbound pressure generated due to the expansive corrosion products released through crack formation. Normally clear cover is the shortest distance to be released. So that the cover concrete is the first affected part of the structure exposed to marine environment. On the other hand, the crack appeared on the surface was found to form along the reinforcement as shown in Figure 5(a). The cracks found on the surface maintaining this pattern can be easily monitored for reinforced concrete structures like bridges. Since the surface crack width maintained a linear relationship with the level of corrosion, this linear relationship between surface crack width and level of corrosion can be an effective tool for corrosion prediction.

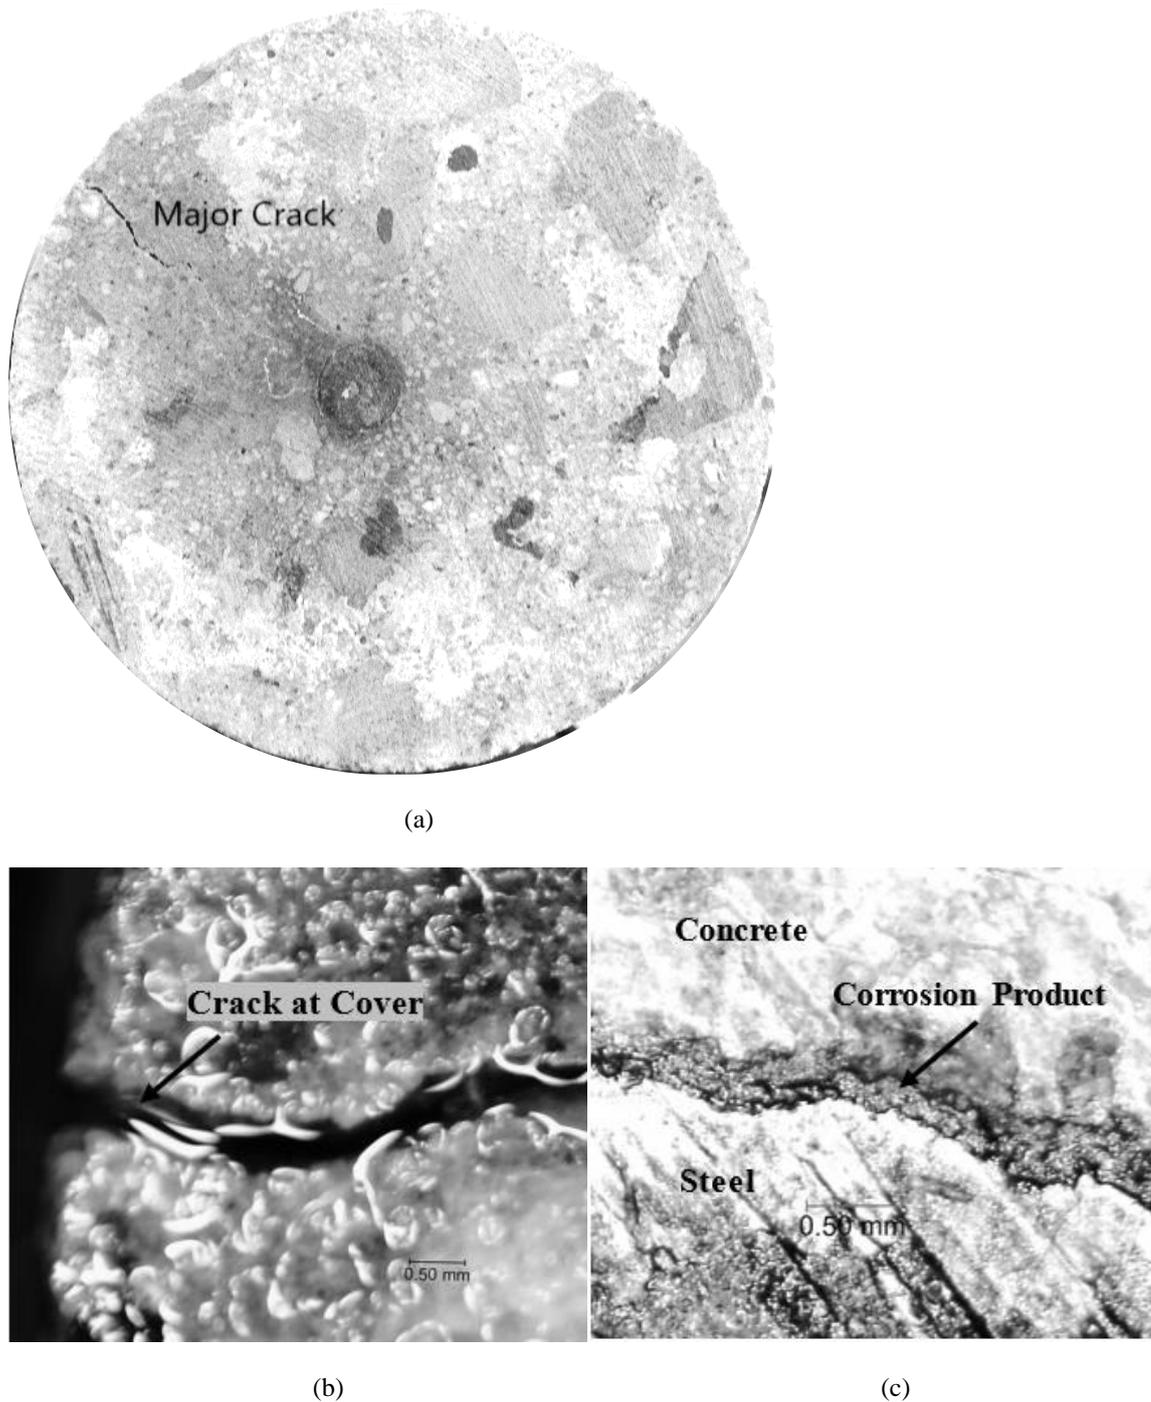
Figure 5. Crack Pattern of the Specimen (a) Cylindrical Plate Specimen (b) Crack Mouth Opening at Cover (c) Corrosion Product Build up at Steel Concrete Interface

With an increase in the amount of corrosion products, a visible crack is initiated from the concrete surface and propagated towards the reinforcement. This phenomenon was also observed in beam specimen for cover of 20 mm and 37.5 mm (Shakib & Morshed 2019) and 30 mm (Tran et al. 2011). This may be due to the bending of the surface (Shakib & Morshed 2019) or cylindrical shape effect. The surface crack width was measured by image analysis. Figure 5 (a) shows one of test specimens with cover cracking. Images were captured by USB microscope as shown in Figure 5 (b) and 5 (c). In Figure 5 (a), a photograph is shown representing the major crack formed through the cover concrete. The figure clearly shows the crack pattern. The magnified photograph of major crack at the cover surface is shown in Figure 5 (b). Another photograph is shown in Figure 5 (c) representing the layer of corrosion products.

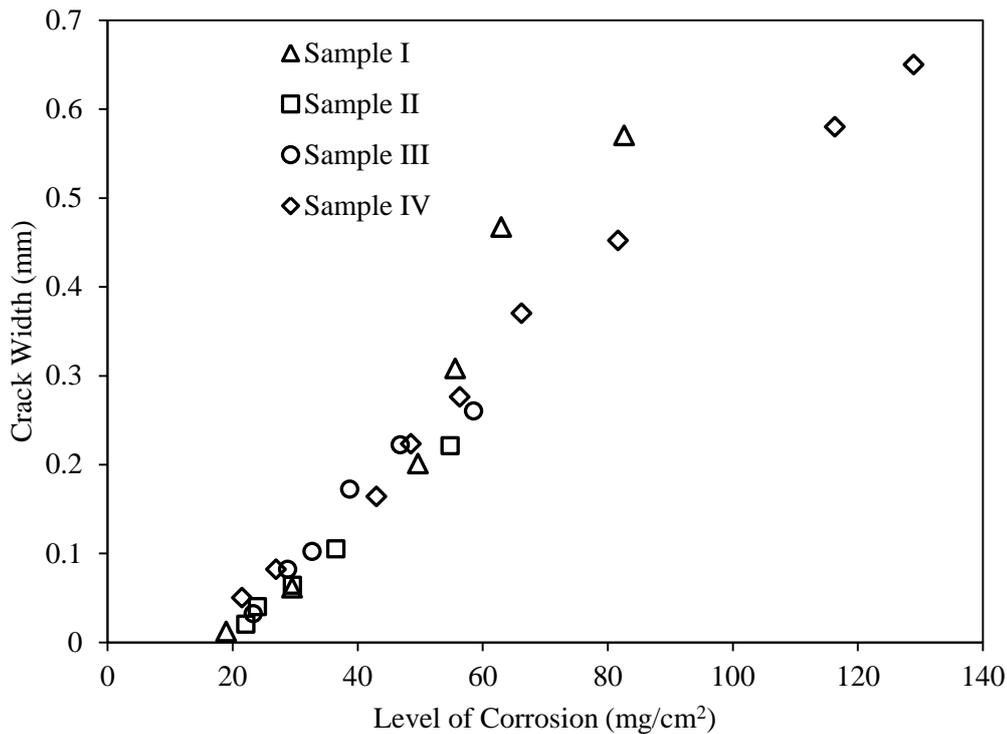
Figure 6. Surface Crack Propagation
